Re: SITE CLOSURE and PECFA REIMBURSEMENT (Claim #s 53209-4603-09 and 53209-4603-10) at Roettgers' Oil Company 5169 N. 37th Street, Milwaukee, WI.

Summary

I have enclosed the environmental remediation report for the Roettgers, Villard site, 3709 W. Villard Avenue, Milwaukee, Wisconsin. Advent recommends that the WDNR close the site. We will forward a copy of this report and the Petroleum Environmental Cleanup Fund Act (PECFA) Form 4 to the WDNR at the following address:

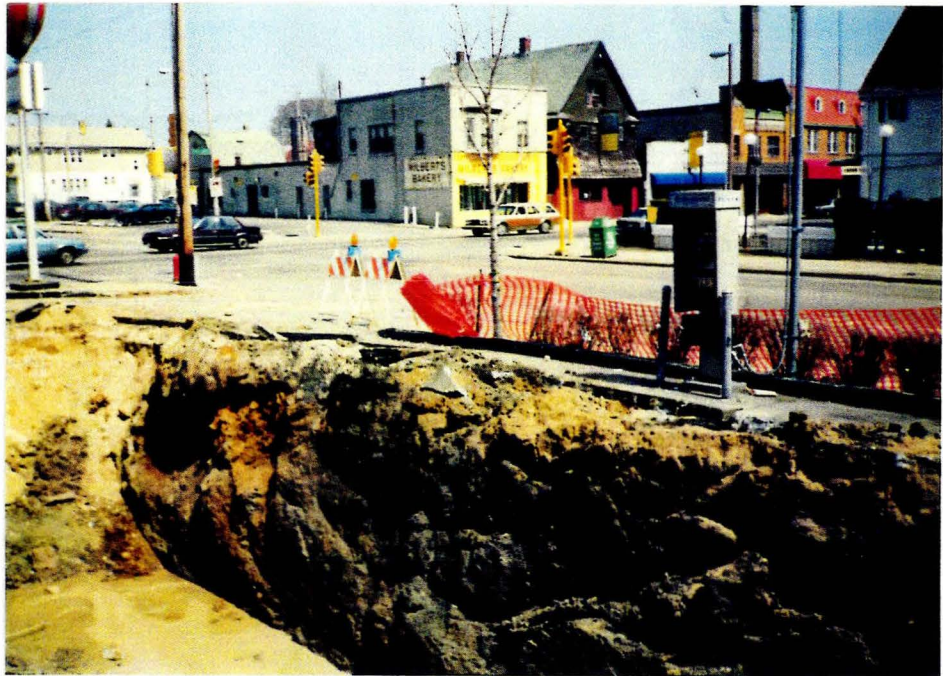
DESCRIPTION: Northeastern wall of excavation, 37th Street to right, Villard Avenue in background.

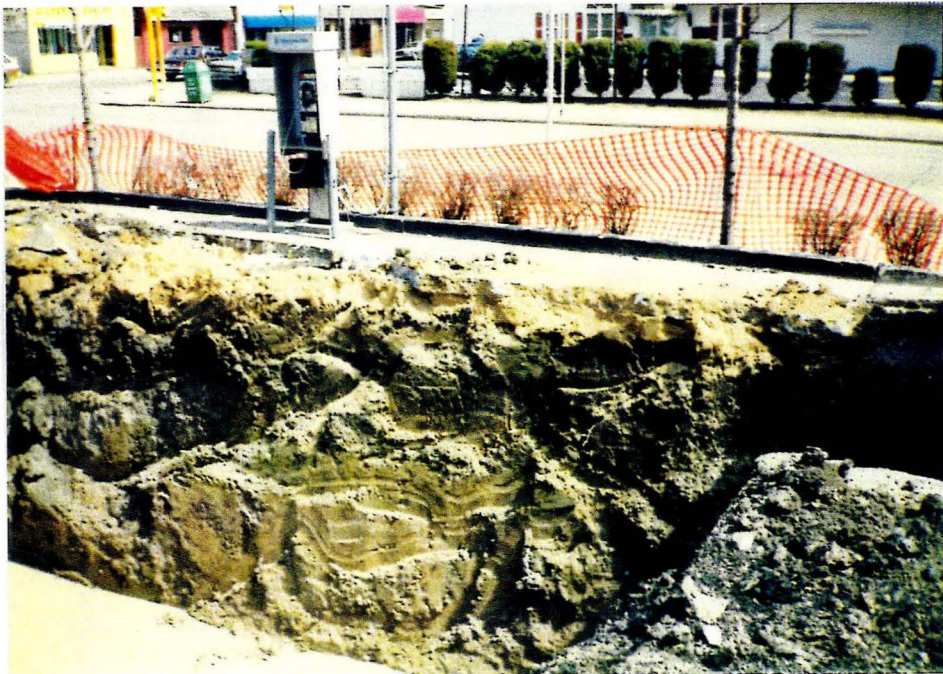
DESCRIPTION: Eastern wall of excavation, 37th Street in background

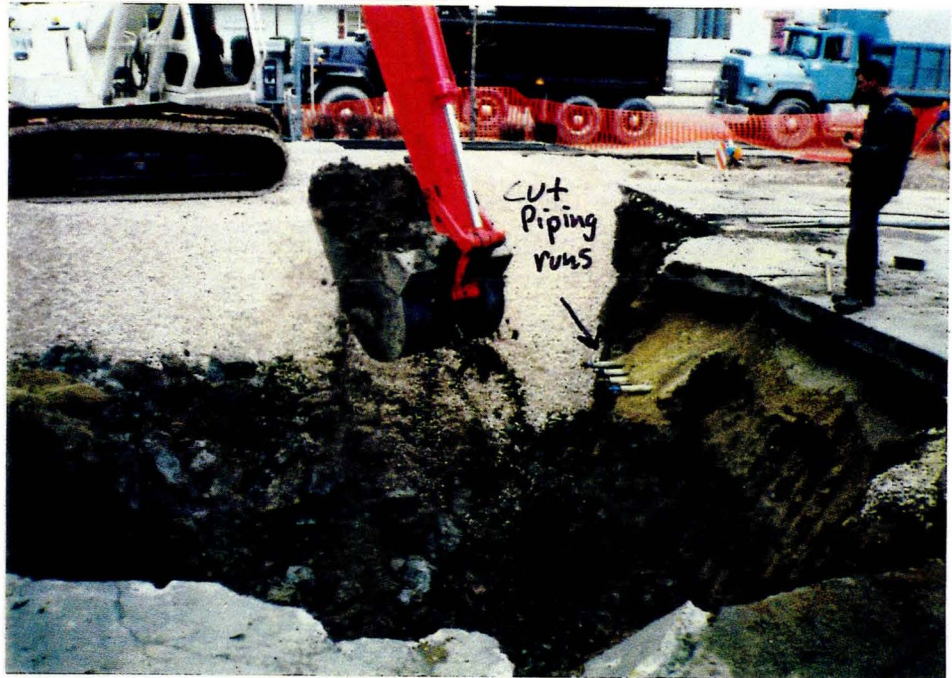
DESCRIPTION: Excavating area north of UST bed, note cut off piping.

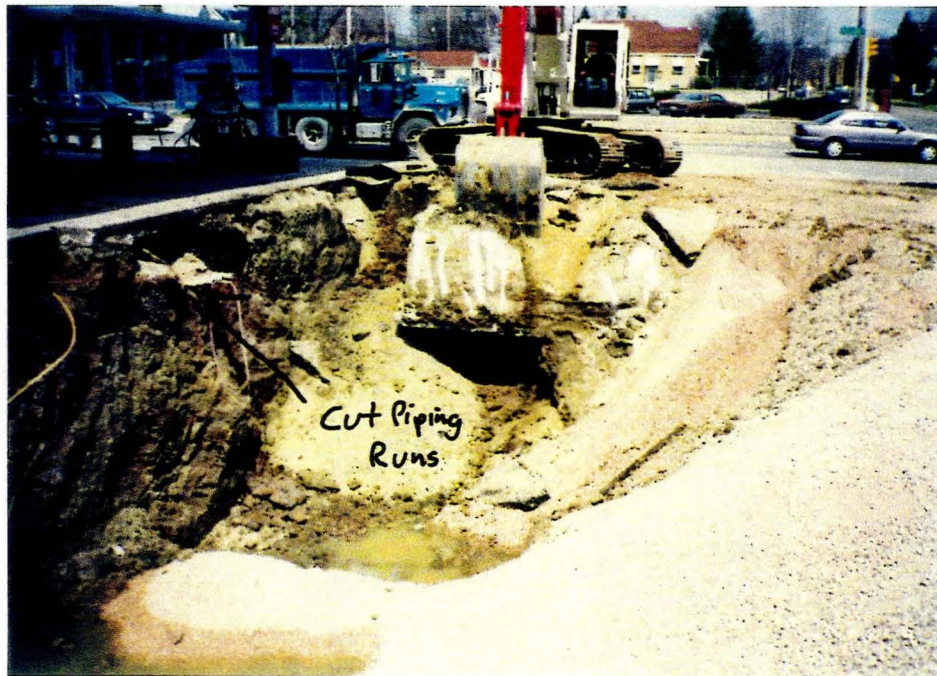
DESCRIPTION: Excavating in area of concrete Villard Avenue is in the background.

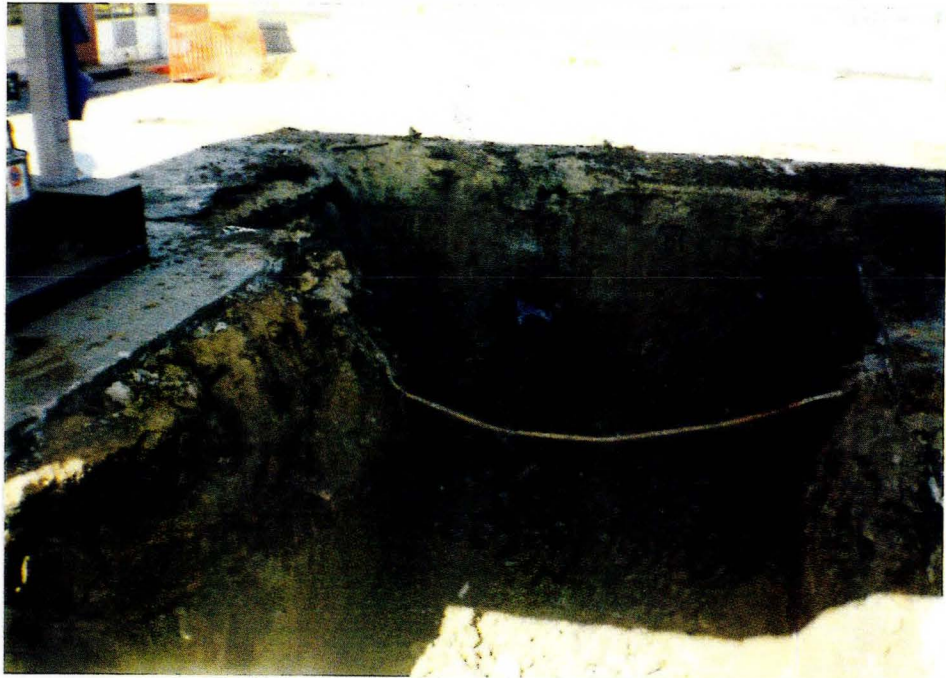
DESCRIPTION: West wall between pump islands.

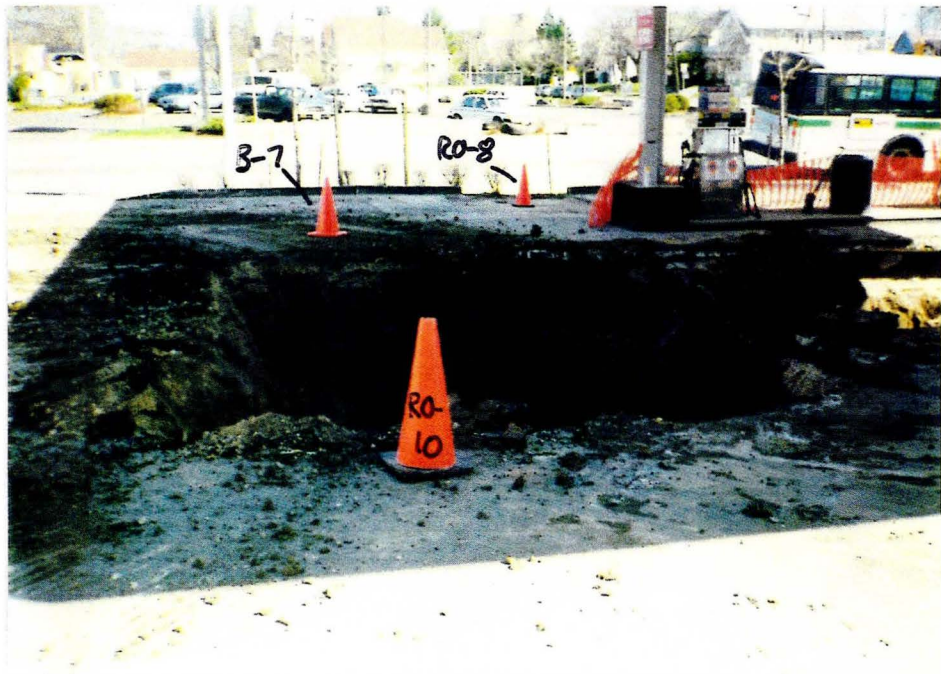
DESCRIPTION: North wall between pump islands, cones mark location of borings completed during site investigation.

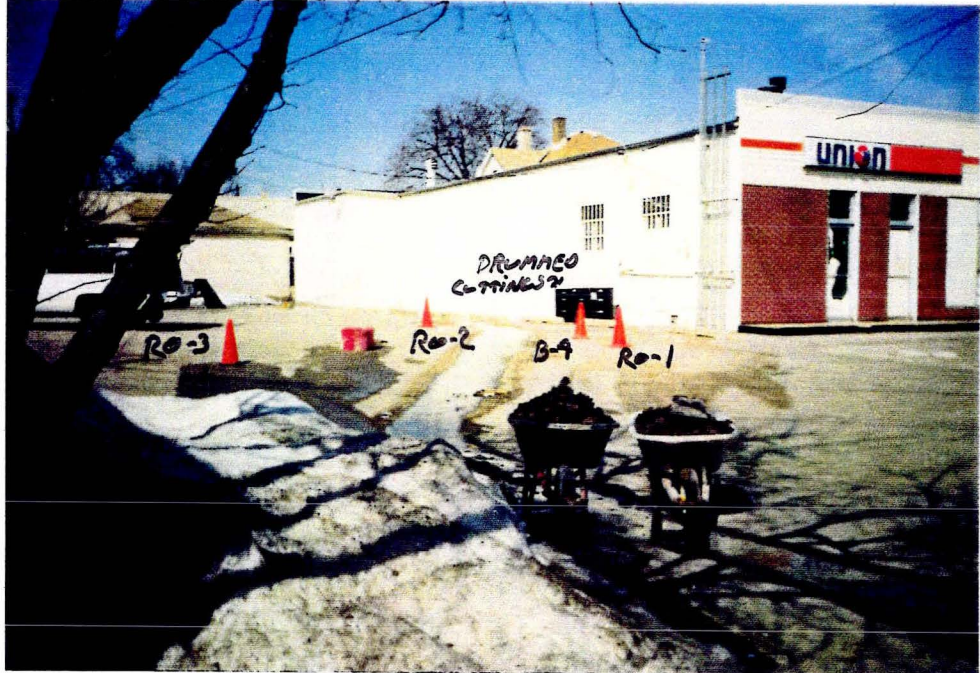
DESCRIPTION: Roettgers Oil site. Orange cones indicate locations of soil borings B-4, RO-1, RO-2, and RO-3. Drummed contaminated soil cuttings are located against south wall of building.

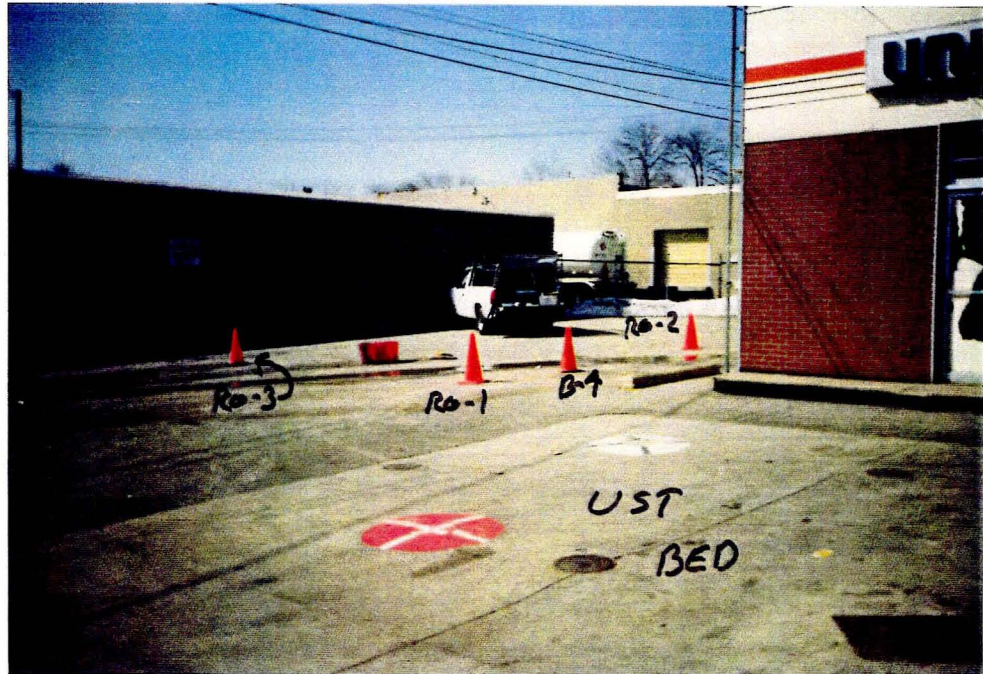
DESCRIPTION: Orange cones indicate locations of soil borings B-4, RO-1, RO-2, and RO-3.

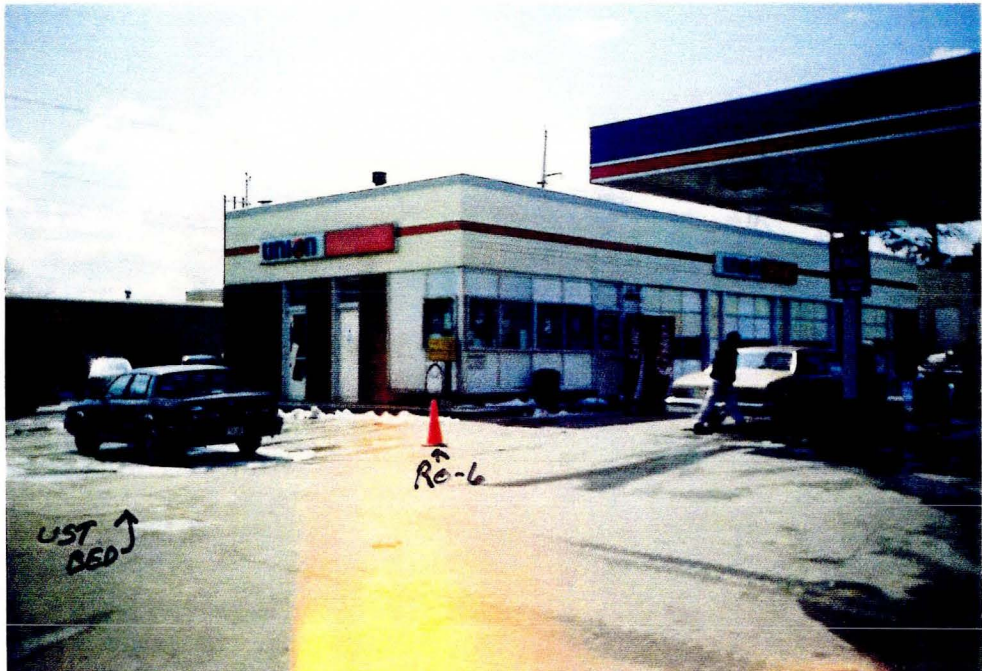
DESCRIPTION: Orange cone indicates location of soil boring RO-6 just north of gasoline UST bed.

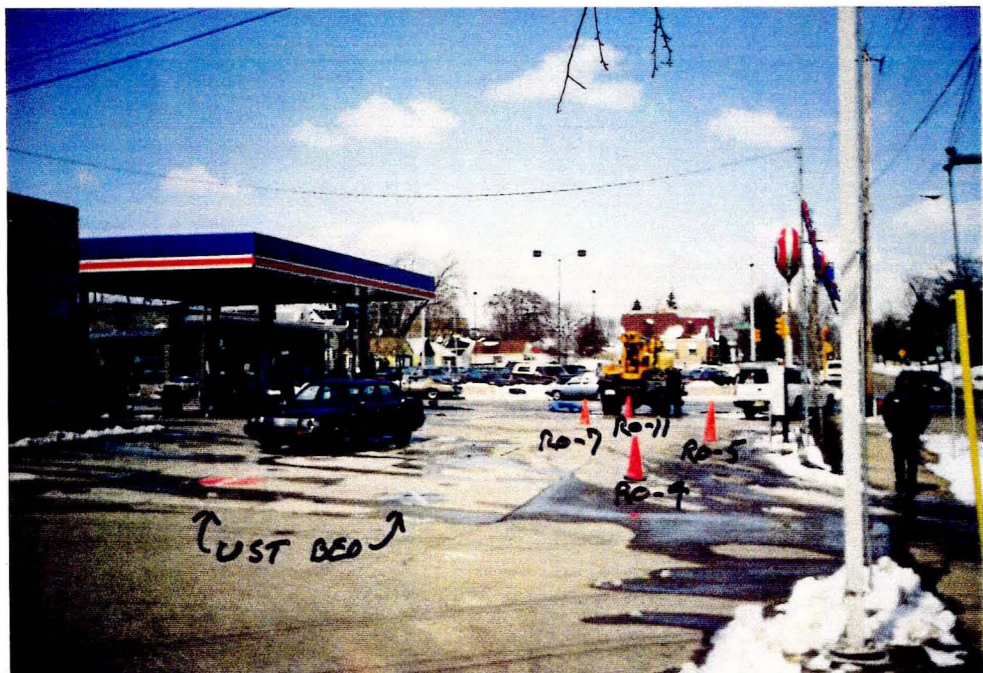
DESCRIPTION: Orange cones indicate locations of soil borings RO-4, RO-5, RO-7, and RO-11.

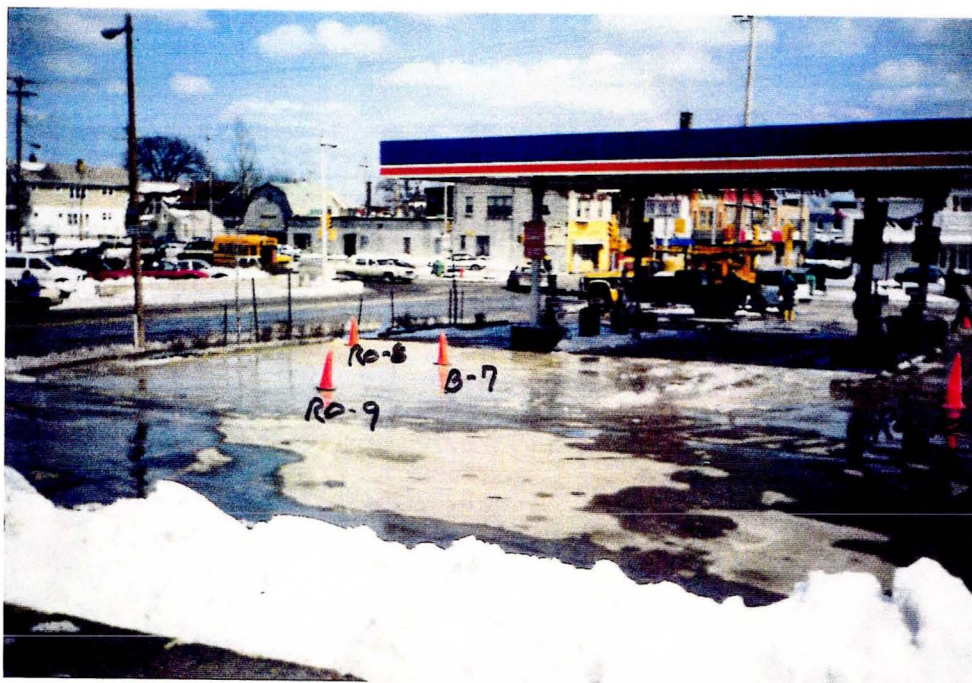
DESCRIPTION: Orange cone indicate locations of soil borings B-7, RO-8, RO-9, and RO-10.

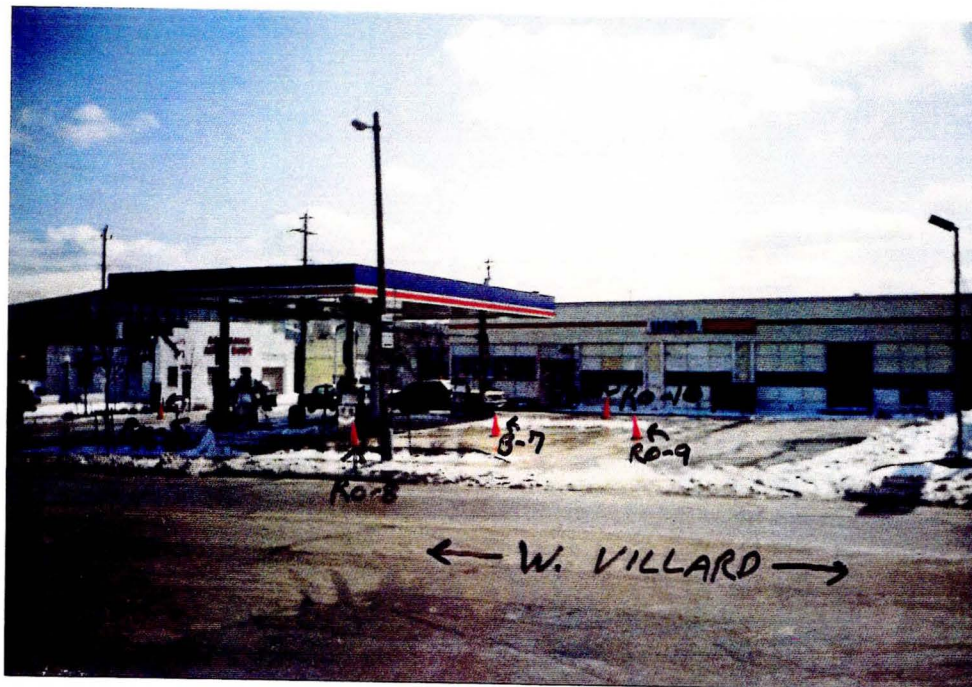
DESCRIPTION: Orange cones indicate locations of soil borings RO-5, RO-8, RO-9, RO-10, and B-7.

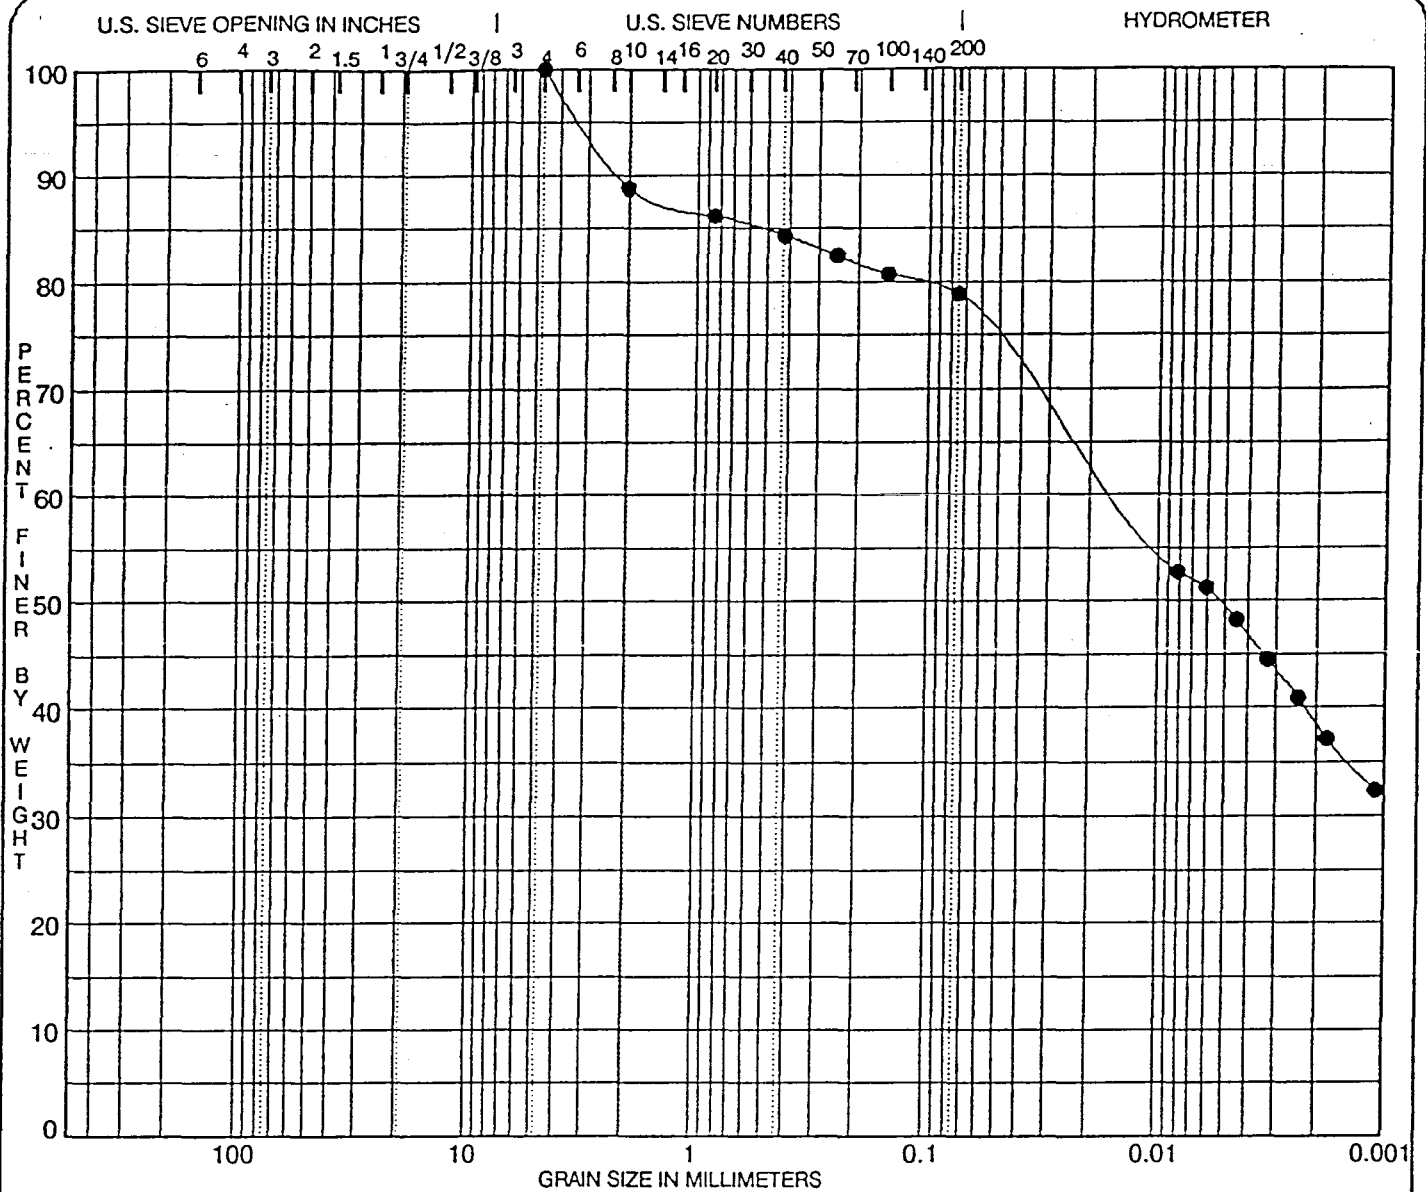
Specimen Identification	Classification				MC%	LL	PL	PI	Cc	Cu
● GTS-1	LEAN CLAY with SAND CL				14.0	39.8	16.3	23.5		
Specimen Identification	D100	D60	D30	D10	%Gravel	%Sand	%Silt	%Clay		
● GTS-1	4.75	0.02			0.0	21.2	29.6	49.2

Results of analysis of a representative soil sample for geotechnical parameters determined that soils at the site are a lean clay with sand with a Unified Soil Classification of CL. Soil at the site is 21.2% sand, 29.6% silt, and 49.2% clay.
